A Fact Finding Mission

Manfred Schobesberger and Rudolf Hemmelmayr, Inspec Fibres, Austria, explain the different tests carried out to determine the causes of filter bag failures.

**WORLD
CEMENT**

August 2002

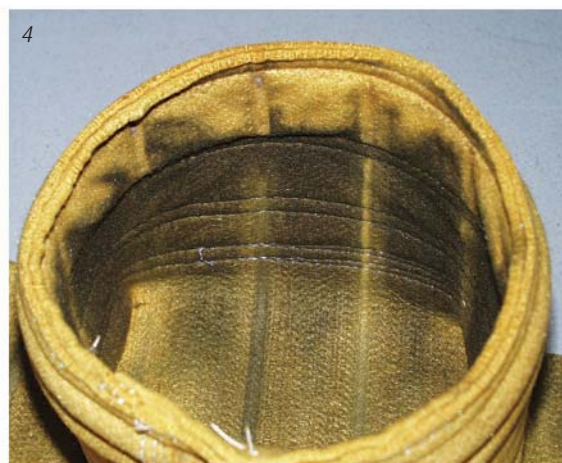
Figure 6 (bottom right). Typical cross-section of used bag.

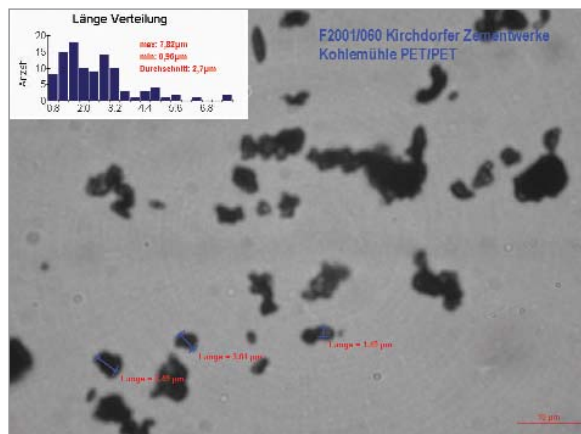
Figure 8. Particle size scan.

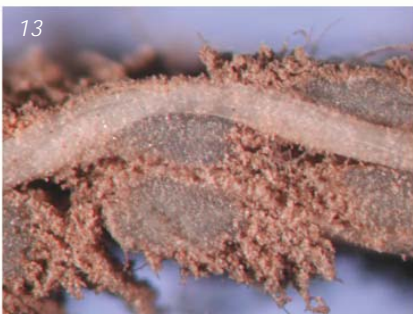
Figure 13. Dust migration through the glass fabric.

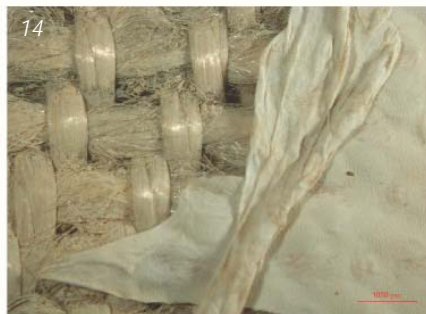
Figure 14. Delaminated membrane.

Failure indications are typically either increased dust emissions, which is a sign of broken bags, or a differential pressure increase caused by blinding and chicken effects (dust deposition behind the membrane). Delamination and particulate membrane dam-

age on the surface allow such problems to arise. The cause is rarely chemical deterioration. In most cases the mechanical burden is responsible for the premature failure and therefore the bag analysis is reduced to microscopic examination of the surface and the cross-section of the bags as well as remaining air permeability. Problems are overcome by changing to less sensitive needle felted materials, reduction of the air to cloth ratio, increased number of cage wires or cyclones upstream of the bag unit to reduce dust burden and abrasion.
